Water Compliance Inspection Report

**NPDES
Inspection Report**

Countryside Dairy, LLC

March 30, 2010

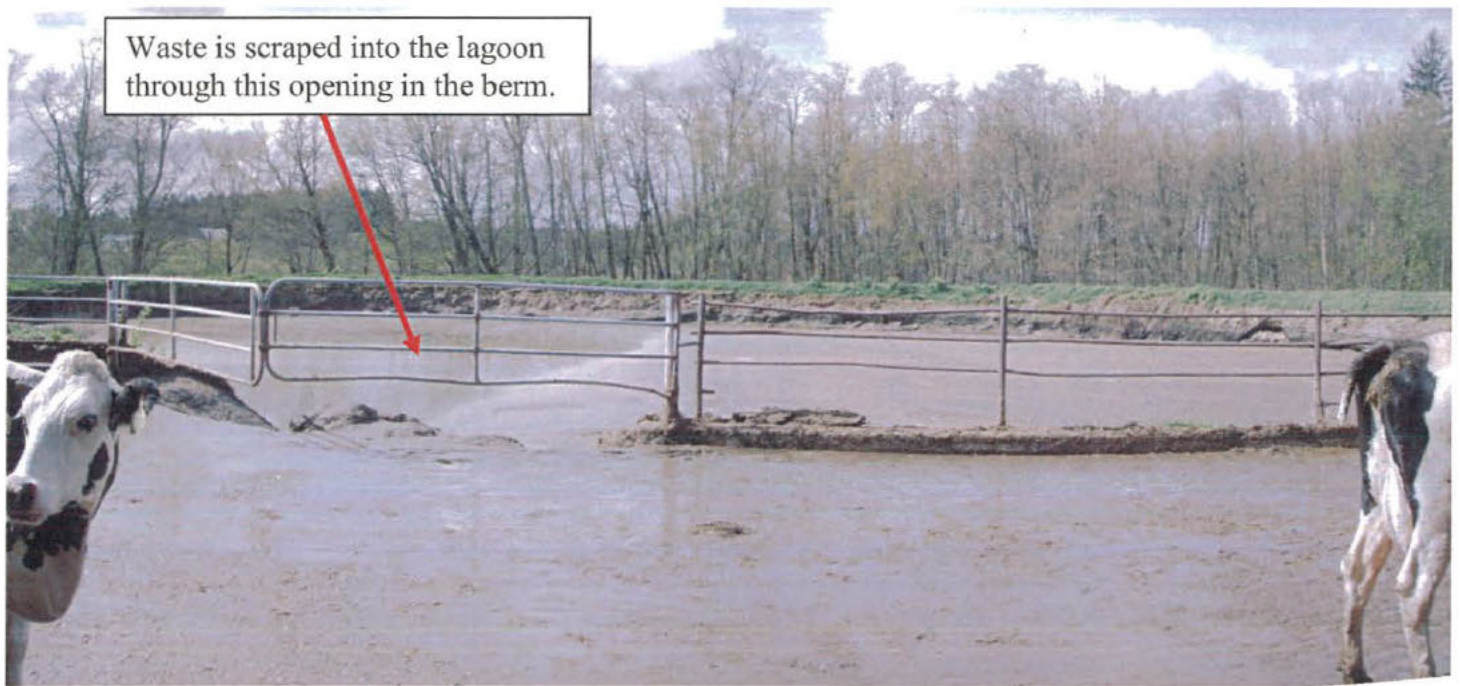
Waste is scraped into the lagoon through this opening in the berm.

Photo #1: An overview of one of two above ground lagoons at the facility. Waste is directly scraped into the lagoons from the barns.

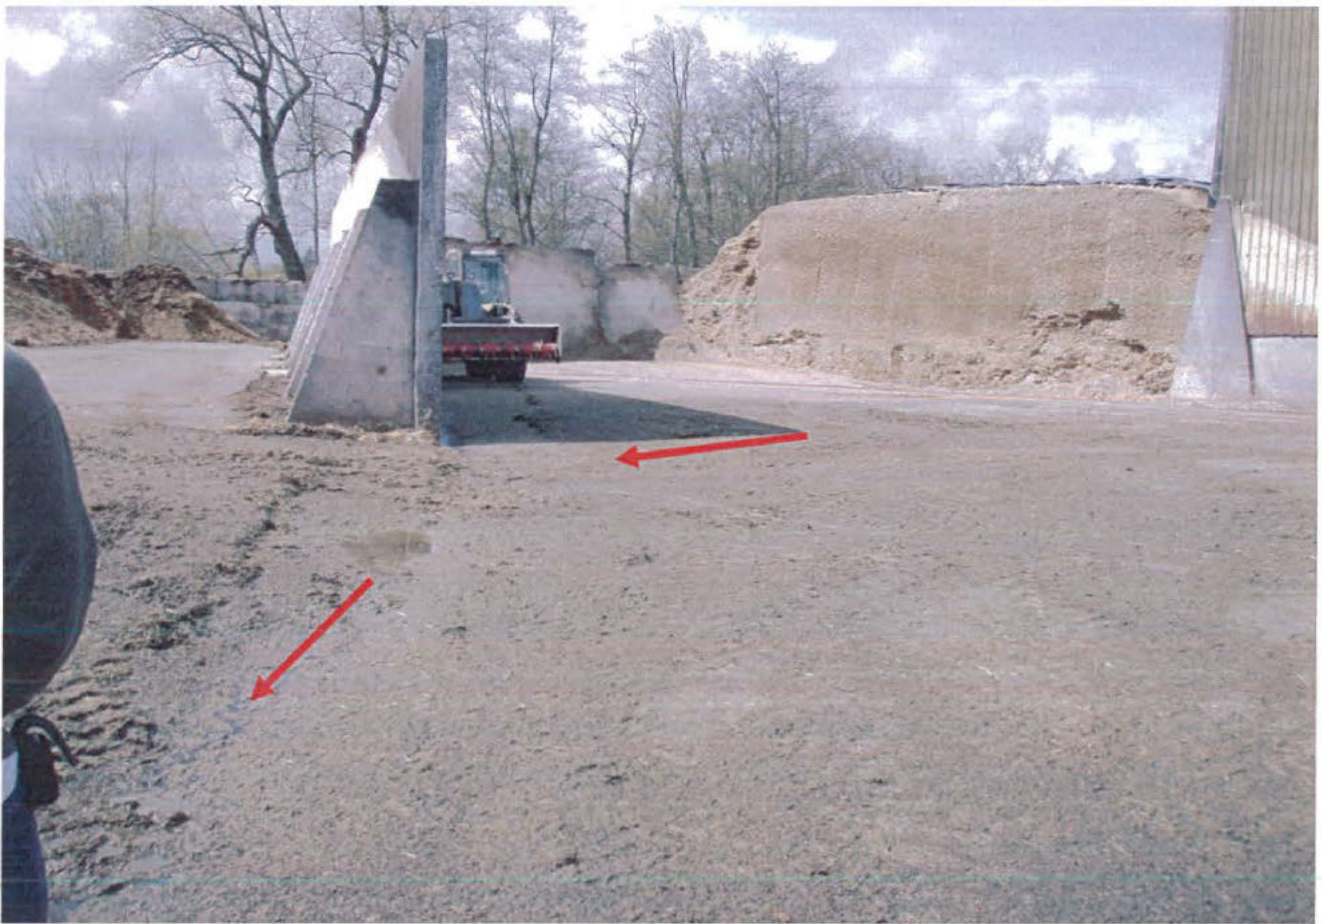
Photo #2: A view of a feed storage area. The red arrows indicate the flow of runoff from this area into the below ground pit.

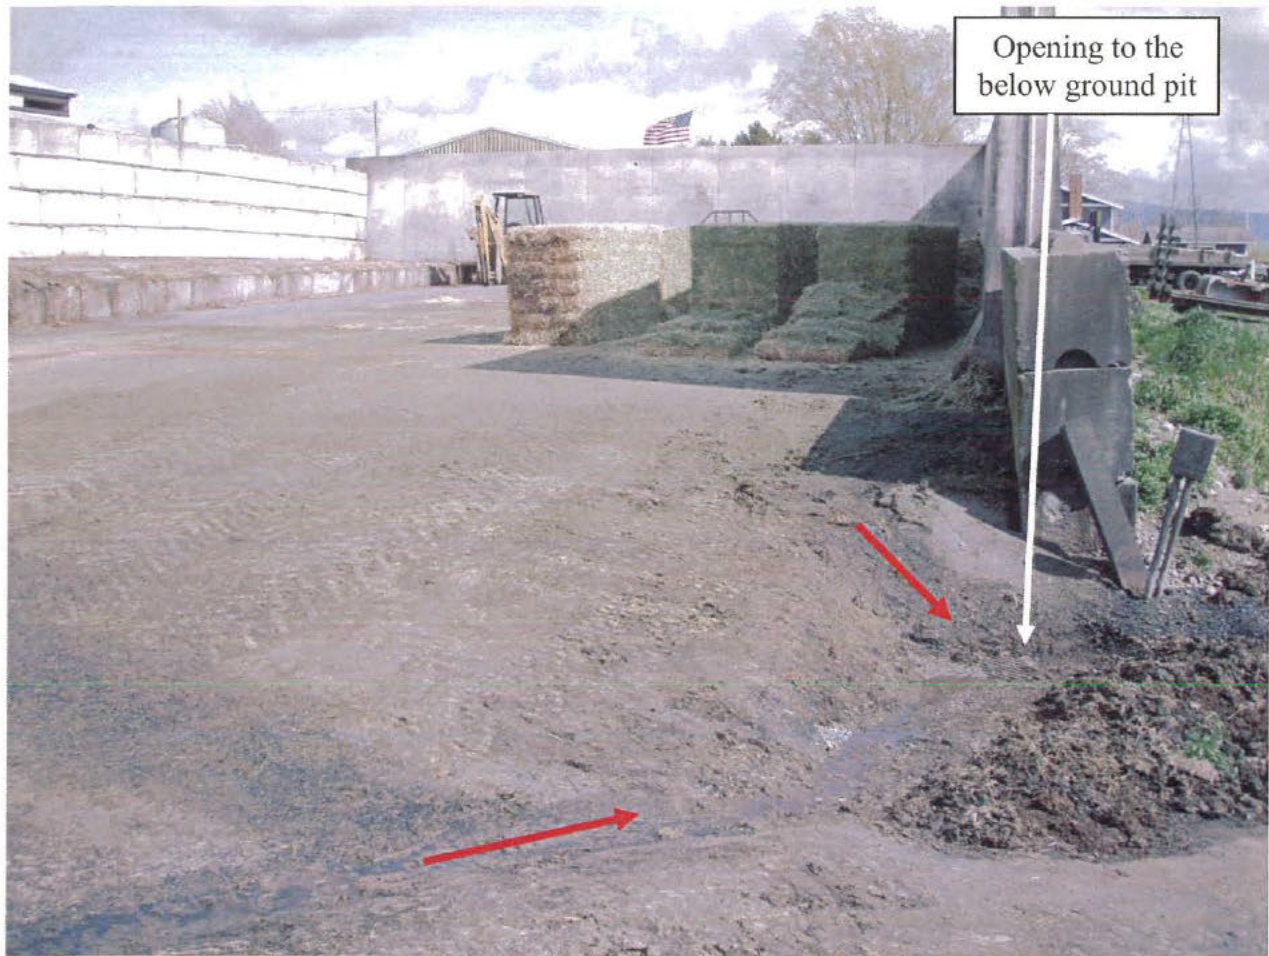
Photo #3: Looking in the opposite direction of the previous picture, this view is a continuation of the flow of runoff from a feed storage area. Also in this view is another feed storage area, where runoff will also be routed to the below ground pit. Waste in this pit is routed to one of the two lagoons. The red arrows indicate the flow of the runoff.
